**Flood Control Project Maintenance
Levee Inspections**

Maintenance Issue Types Only, Levee Inspection Report By Mile - Spring 2018

Sutter Maintenance Yard Tisdale Bypass

Waterway	Bank	Unit Miles	Inspection Start/End	Inspector
Unit No. 01 Tisdale Bypass	Left	4.51	03/27/2018 03/27/2018	Bob Duffey

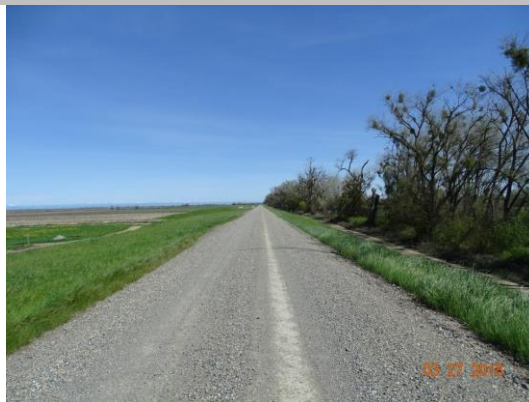
Photo 1 of 1 : SP_2018_ST0009_286_10_20180403_00020.jpg

LM Start	1.08	Rating **	A	Issue No.	10
LM End	1.08	Issue Type +	Ma	Location *	LS
Category	Earthen Levee			GPS Latitude/Longitude	
				Start	End
Item	Vegetation			39.028307 °	39.028307 °
				-121.801960 °	-121.801960 °
DWR ID	DWR_ST0009_01_s_2018_10				
Comment Code					
V1 : Control annual grass and weeds on the levee slopes and easements.					
Inspector Comment					
Lma should continue to manage the native grasses on both slopes.

View of native grasses on both slopes.

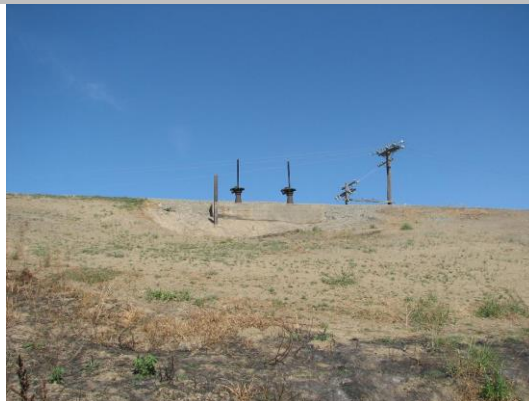
Photo 1 of 3 : UCIP_SP_2018_51484_64226.jpg

FS_ID:51484
DS_ID:16591
EP_NO: 10099
Repair Type: No Action Needed
Crossing Status: Found
UCIP Comments: 4/10/2017 Crossing appears to be in good condition.
(DWR Sutter Yard- AFreitag)10/11/2016 Crossing appears to be in good condition.(DWR Sutter Yard - afreitag)4/18/2016 Crossing appears to be in good condition. No noticeable issues to report.5/7/2015 Crossing is in good condition. No noticeable issues to report.11/13/2014 Same as last inspection.5/12/2014 Same as last inspection.10/30/2013 Same as last inspection.5/20/2013 Same as last inspection.
FIELD_STRUCT_DESC: 1 of 2: 4-foot by 7-foot reinforced concrete discharge tunnel through the levee, 38 feet below the crown. Slide gate in 4-foot by 15-foot concrete well on the waterside (WS) slope. Pump house located on the landside (LS) toe and wooden flap gates on the WS toe. (two 4-foot by 7-foot tunnel [HLM 2.13] authorized under Automatic Board Order (ABO) issued as Permit No. 10099, 1955 - Reclamation District No. 1660). [Additional Reference(s): DWR Levee Log, 1993. USACE Sacramento O&M Manual 133, August 1955 (Station 1044+60)].

Slide gates on WS shoulder.

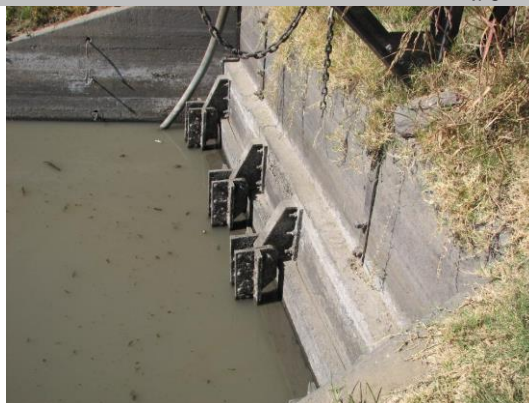
Photo 2 of 3 : UCIP_SP_2018_51484_64225.jpg

Wooden Flap gates on WS toe.

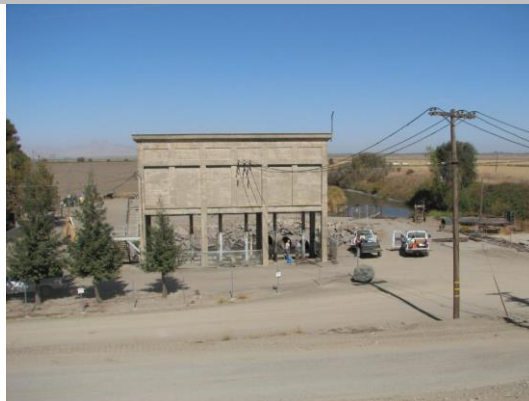
Photo 3 of 3 : UCIP_SP_2018_51484_64224.jpg

FS_ID:51484
DS_ID:16591
EP_NO: 10099
Repair Type: No Action Needed
Crossing Status: Found
UCIP Comments: 4/10/2017 Crossing appears to be in good condition.
(DWR Sutter Yard- AFreitag)10/11/2016 Crossing appears to be in good condition.(DWR Sutter Yard - afreitag)4/18/2016 Crossing appears to be in good condition. No noticeable issues to report.5/7/2015 Crossing is in good condition. No noticeable issues to report.11/13/2014 Same as last inspection.5/12/2014 Same as last inspection.10/30/2013 Same as last inspection.5/20/2013 Same as last inspection.
FIELD_STRUCT_DESC: 1 of 2: 4-foot by 7-foot reinforced concrete discharge tunnel through the levee, 38 feet below the crown. Slide gate in 4-foot by 15-foot concrete well on the waterside (WS) slope. Pump house located on the landside (LS) toe and wooden flap gates on the WS toe. (two 4-foot by 7-foot tunnel [HLM 2.13] authorized under Automatic Board Order (ABO) issued as Permit No. 10099, 1955 - Reclamation District No. 1660). [Additional Reference(s): DWR Levee Log, 1993. USACE Sacramento O&M Manual 133, August 1955 (Station 1044+60)].

Pump house on LS toe.

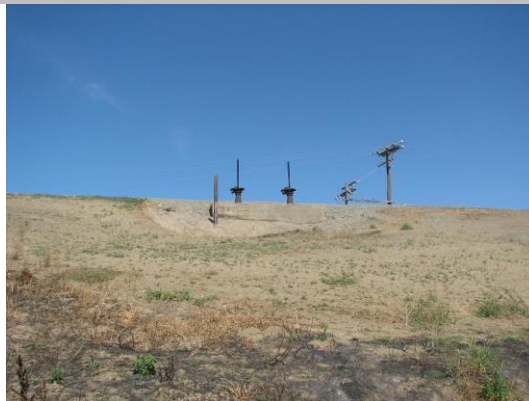
Photo 1 of 3 : UCIP_SP_2018_51485_64230.jpg

FS_ID:51485
DS_ID:16856
EP_NO: 10099
Repair Type: No Action Needed
Crossing Status: Found
UCIP Comments: 4/10/2017 Crossing appears to be in good condition.
(DWR Sutter Yard- AFreitag)10/11/2016 Crossing appears to be in good condition.(DWR Sutter Yard - afreitag)4/18/2016 Crossing appears to be in good condition. No noticeable issues to report.5/7/2015 Crossing is in good condition. No noticeable issues to report.11/13/2014 Same as last inspection.5/12/2014 Same as last inspection.10/30/2013 Same as last inspection.5/20/2013 Same as last inspection.
FIELD_STRUCT_DESC: 2 of 2: 4-foot by 7-foot concrete discharge tunnel through the levee, 38 feet below the crown. Slide gate in 4-foot by 15-foot concrete well on the waterside (WS) slope. Pump house located on the landside (LS) toe and wooden flap gates on the WS toe. (two 4-foot by 7-foot tunnel [HLM 2.13] authorized under Automatic Board Order (ABO) issued as Permit No. 10099, 1955 - Reclamation District No. 1660). [Additional Reference(s): DWR Levee Log, 1993. USACE Sacramento O&M Manual 133, August 1955 (Station 1044+60)].

Slide gates on WS shoulder.

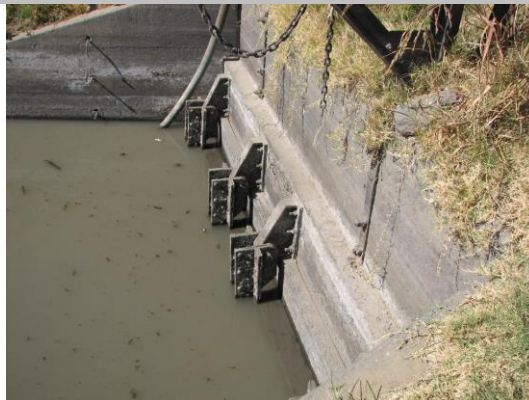
Photo 2 of 3 : UCIP_SP_2018_51485_64229.jpg

Wooden flap gates on WS toe.

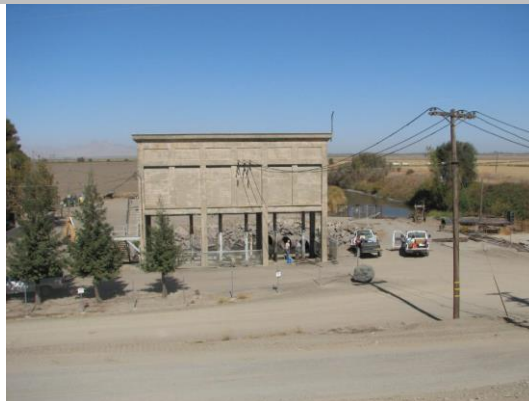
Photo 3 of 3 : UCIP_SP_2018_51485_64228.jpg

Comment Code						
Inspector Comment						
FS_ID:51485 DS_ID:16856 EP_NO: 10099 Repair Type: No Action Needed Crossing Status: Found UCIP Comments: 4/10/2017 Crossing appears to be in good condition. (DWR Sutter Yard- AFreitag)10/11/2016 Crossing appears to be in good condition.(DWR Sutter Yard - afreitag)4/18/2016 Crossing appears to be in good condition. No noticeable issues to report.5/7/2015 Crossing is in good condition. No noticeable issues to report.11/13/2014 Same as last inspection.5/12/2014 Same as last inspection.10/30/2013 Same as last inspection.5/20/2013 Same as last inspection. FIELD_STRUCT_DESC: 2 of 2: 4-foot by 7-foot concrete discharge tunnel through the levee, 38 feet below the crown. Slide gate in 4-foot by 15-foot concrete well on the waterside (WS) slope. Pump house located on the landside (LS) toe and wooden flap gates on the WS toe. (two 4-foot by 7-foot tunnel [HLM 2.13] authorized under Automatic Board Order (ABO) issued as Permit No. 10099, 1955 - Reclamation District No. 1660). [Additional Reference(s): DWR Levee Log, 1993. USACE Sacramento O&M Manual 133, August 1955 (Station 1044+60)]. FS Date: 4/12/2017 9:20:37 AM

Pump house on LS toe.

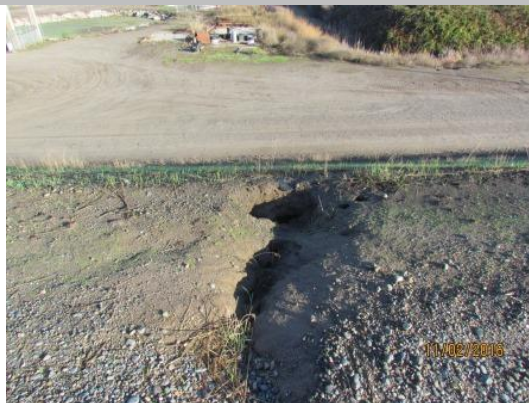
Photo 1 of 2 : SP_2018_ST0009_286_12_20180305_00003.jpg

LM Start	2.16	Rating **	U	Issue No.	12
LM End	2.16	Issue Type +	Ma	Location *	LS
Category	Earthen Levee			GPS Latitude/Longitude	
				Start	End
Item	Animal Control			39.028137 °	39.028137 °
				-121.782020 °	-121.782020 °
DWR ID	DWR_ST0009_01_f_2016_12				
Comment Code					
A3 : No rodents visible, but rodent burrows visible; need to backfill and compact or grout burrows.					
Inspector Comment

View of a rodent hole along the levee crown.

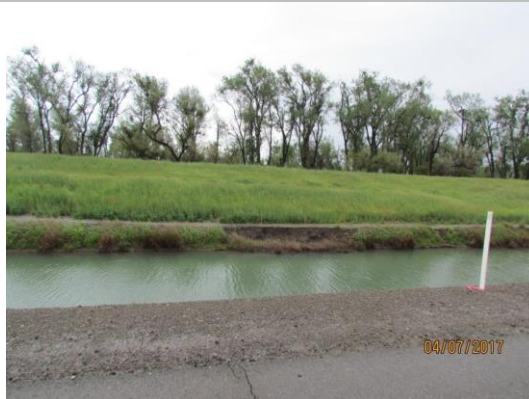
Photo 1 of 1 : SP_2018_ST0009_287_9_20180305_00005.jpg

LM Start	0.69	Rating **	M	Issue No.	9
LM End	0.71	Issue Type +	Ma	Location *	LS
Category	Earthen Levee			GPS Latitude/Longitude	
				Start	End
Item	Erosion / Bank Caving			39.025602 °	39.025657 °
				-121.808527 °	-121.808027 °
DWR ID	DWR_ST0009_02_s_2017_9				
Comment Code					
E2 : Schedule repair of erosion site prior to the next inspection.					
Inspector Comment					
Repair the erosion along the landside toe.

View of the erosion along the landside toe from the County Road.

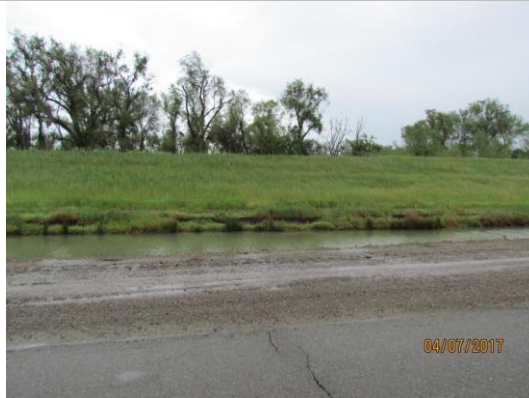
Photo 1 of 1 : SP_2018_ST0009_287_10_20180305_00006.jpg

LM Start	0.97	Rating **	M	Issue No.	10
LM End	0.98	Issue Type +	Ma	Location *	LS
Category	Earthen Levee			GPS Latitude/Longitude	
				Start	End
Item	Erosion / Bank Caving			39.025540 °	39.025572 °
				-121.803272 °	-121.802990 °
DWR ID	DWR_ST0009_02_s_2017_10				
Comment Code					
E2 : Schedule repair of erosion site prior to the next inspection.					
Inspector Comment					
Repair the erosion along the landside toe.

View of the erosion along the landside toe from the County Road.

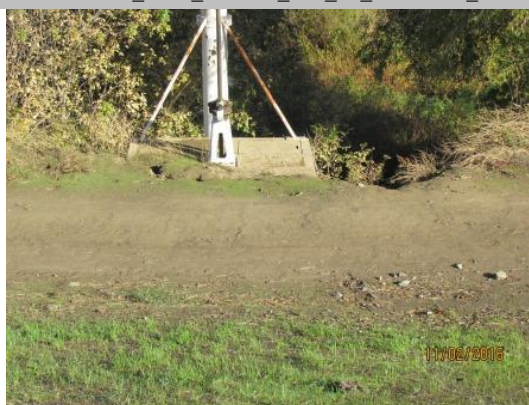
Photo 2 of 2 : SP_2018_ST0009_287_13_20180305_00008.jpg

Another view of the erosion along the concrete vault.

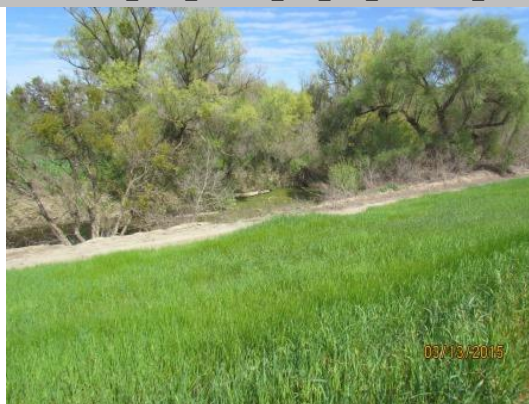
Photo 1 of 1 : SP_2018_ST0009_287_290_20180305_00010.jpg

LM Start	1.19	Rating **	A/W	Issue No.	290
LM End	1.19	Issue Type +	Ma	Location *	WS
Category	Earthen Levee			GPS Latitude/Longitude	
				Start	End
Item	Erosion / Bank Caving			39.025490 °	39.025490 °
				-121.799240 °	-121.799240 °
DWR ID	DWR_ST0009_02_s_2015_290				
Comment Code					
E1 : Note and monitor erosion site.					
Inspector Comment					
Sutter Yard needs to monitor the erosion along the berm.

View of the erosion along the waterside berm.

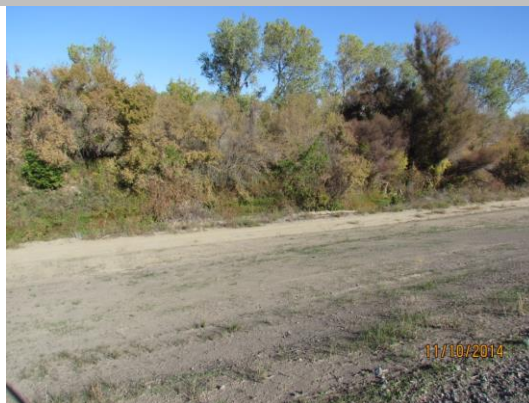
Photo 1 of 1 : SP_2018_ST0009_287_4_20180305_00003.jpg

LM Start	1.29	Rating **	A/W	Issue No.	4
LM End	1.29	Issue Type +	Ma	Location *	WS
Category	Earthen Levee			GPS Latitude/Longitude	
				Start	End
Item	Erosion / Bank Caving			39.025478 °	39.025478 °
				-121.797232 °	-121.797232 °
DWR ID	DWR_ST0009_02_s _ 2013_4				
Comment Code					
E2 : Schedule repair of erosion site prior to the next inspection.					
Inspector Comment					
Sutter Yard needs to monitor the erosion.

View of the erosion along the waterside berm.

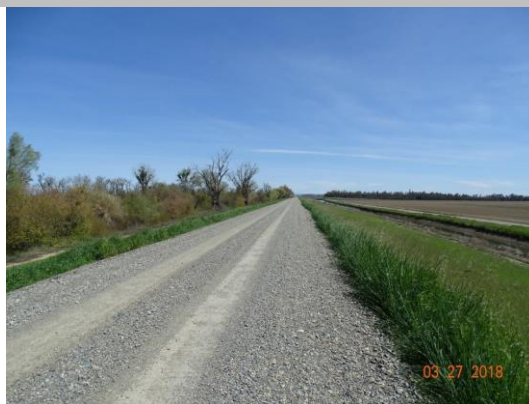
Photo 1 of 1 : SP_2018_ST0009_287_7_20180403_00017.jpg

LM Start	1.35	Rating **	M	Issue No.	7
LM End	1.35	Issue Type +	Ma	Location *	LS
Category	Earthen Levee			GPS Latitude/Longitude	
				Start	End
Item	Vegetation			39.025445 °	39.025445 °
				-121.796092 °	-121.796092 °
DWR ID	DWR_ST0009_02_s _ 2018_7				
Comment Code					
V1 : Control annual grass and weeds on the levee slopes and easements.					
Inspector Comment					
Removed the native grasses on both slopes.

View of native grasses on both slopes.

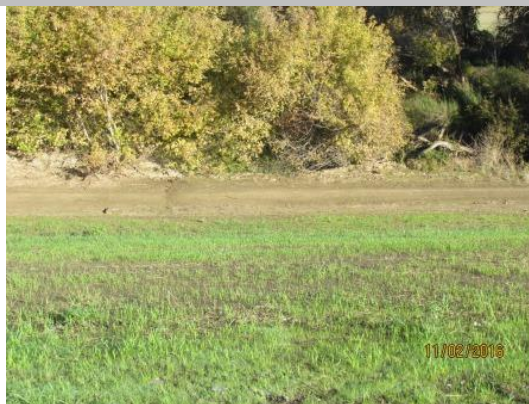
Photo 1 of 1 : SP_2018_ST0009_287_5_20180305_00004.jpg

LM Start	1.48	Rating **	A/W	Issue No.	5
LM End	1.50	Issue Type +	Ma	Location *	WS
Category	Earthen Levee			GPS Latitude/Longitude	
				Start	End
Item	Erosion / Bank Caving			39.025460 °	39.025446 °
				-121.793815 °	-121.793347 °
DWR ID	DWR_ST0009_02_s _ 2013_5				
Comment Code					
E2 : Schedule repair of erosion site prior to the next inspection.					
Inspector Comment					
Sutter Yard needs to monitor the erosion.

View of the erosion along the waterside berm.

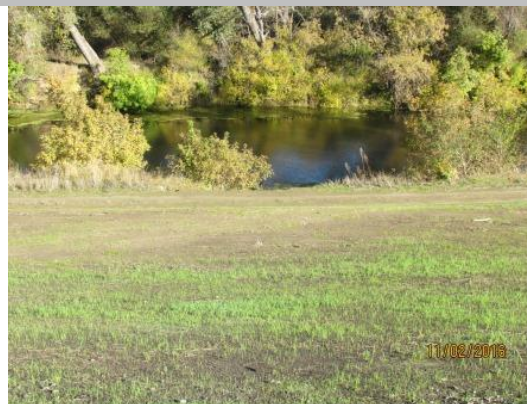
Photo 1 of 1 : SP_2018_ST0009_287_2_20180305_00002.jpg

LM Start	3.93	Rating **	A/W	Issue No.	2
LM End	3.93	Issue Type +	Ma	Location *	WS
Category	Earthen Levee			GPS Latitude/Longitude	
				Start	End
Item	Erosion / Bank Caving			39.025060 °	39.025060 °
				-121.748178 °	-121.748178 °
DWR ID	DWR_ST0009_02_f_2016_2				
Comment Code					
E1 : Note and monitor erosion site.					
Inspector Comment

View of the erosion along the waterside berm.

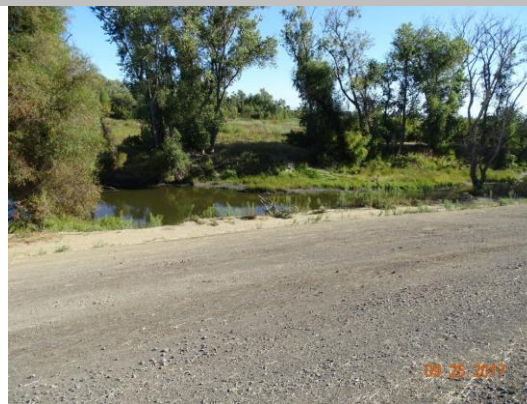
Photo 1 of 1 : SP_2018_ST0009_287_18_20180305_00009.jpg

LM Start	4.09	Rating **	A/W	Issue No.	18
LM End	4.09	Issue Type +	Ma	Location *	WS
Category	Earthen Levee			GPS Latitude/Longitude	
				Start	End
Item	Erosion / Bank Caving			39.024912 °	39.024912 °
				-121.745237 °	-121.745237 °
DWR ID	DWR_ST0009_02_f_2017_18				
Comment Code					
E2 : Schedule repair of erosion site prior to the next inspection.					
Inspector Comment					
Repair the erosion along the water side berm.

View of the erosion along the waterside berm.
